**SECURE DOCUMENT STORAGE FACILITY
BAGHDAD, IRAQ**

SUSTAINMENT ASSESSMENT

**SIGIR PA-08-166
OCTOBER 20, 2009**

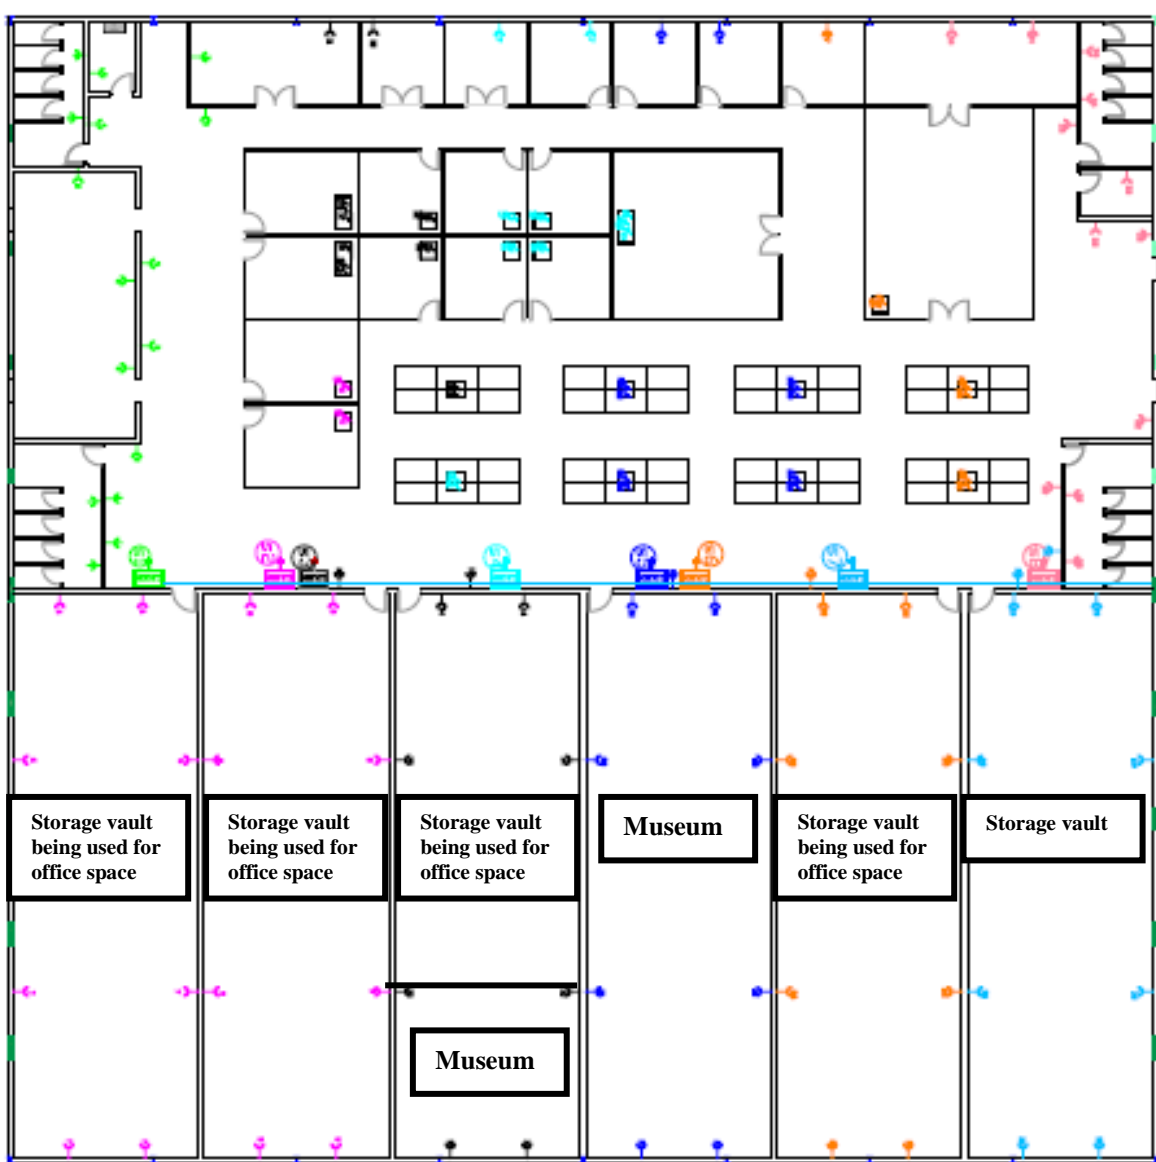
Figure 5. Interior layout of the SDSF (Courtesy of GRC)

The SOW required that half of the 2,500m² building would consist of storage vaults to safely and securely maintain critical paperwork and evidence to be used at upcoming criminal trials. The SOW also required four 12.5m x 25m storage vaults with masonry walls and concrete ceilings. However, a July 2006 MFR stated that “both the customer and the contractor have agreed that 6 storage rooms instead of the specified 4 storage rooms would provide more functional space.” As a result, the final design and construction comprised six storage vaults (Figure 5).

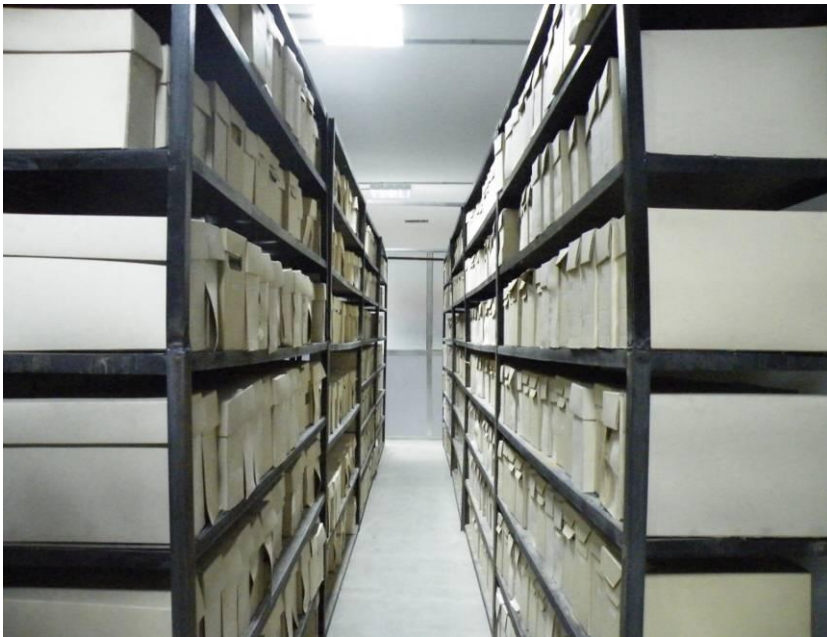
Site Photo 4. Documents stored within the SDSF storage vault room

transferred incrementally to the SDSF. The storage vault rooms were rectangular shaped with only one entrance/exit door. The SDSF facility manager showed SIGIR the one vault room that is currently storing all of the facility's evidence. This room consisted of metal shelving units filled with boxes of documents (Site Photo 4). According to the SDSF facility manager, the U.S. Department of Justice and the Federal Bureau of Investigation assisted IHT representatives with the proper handling of evidence. For example, each document received is given a unique record identifier number and a computer barcode (Site Photo 5).

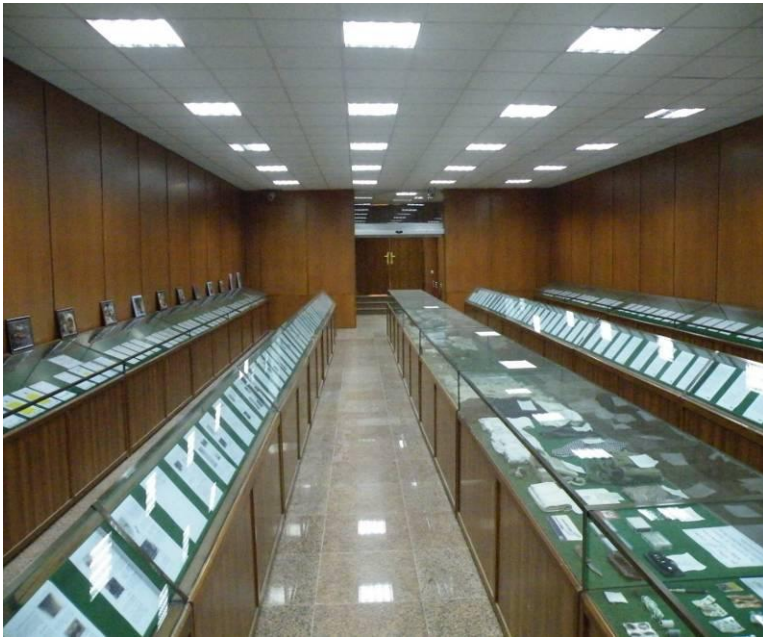
Site Photo 6. Interior view of museum

According to the SDSF facility manager, the IHT authorized and funded the remodeling of one storage vault room and a portion of another room into a museum. This museum will be a testament to the former regime's 30-year reign of terror. For example, critical pieces of evidence produced for the Al Anfal Campaign trial will be made available, such as one document which stated the following (Site Photo 6):

The IHT placed wood paneling on the walls of the storage vault, added new tile to the floor, and created an exquisite rear door.
